Homes for Haringey

**BROADWATER FARM ESTATE
STRUCTURAL ROBUSTNESS ASSESSMENT
KENLEY AND NORTHOLT REPORT**

April 2018

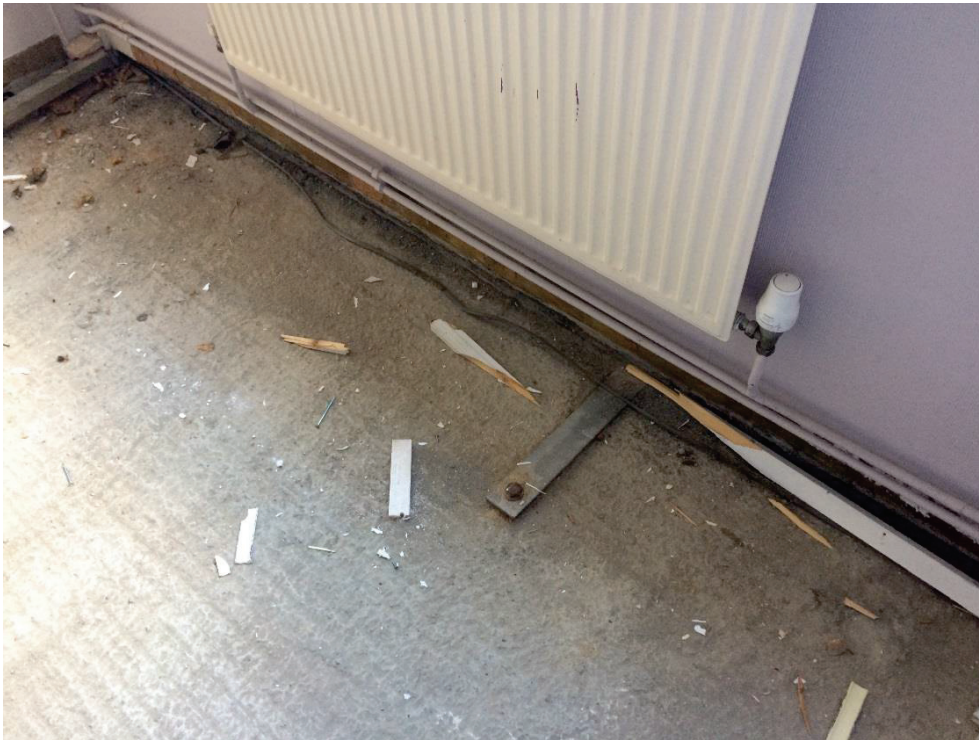
A method for fixing back the external non-loadbearing wall, thought to be an original detail, was observed in the form of a steel strap anchored with a single bolt into the top of the floor slab, see Figure 3. These steel straps were also located approximately midway along the base of the external walls in each room.

Figure 3 – Hawkinge: Strap tying base of external wall panel back to the floor slab

This steel restraint strap extends passed the end of the floor slab, running under the non-loadbearing external wall panels. The strap is tied to the wall panel by a 25mm diameter threaded bar protruding up from the wall panel below, passing through a hole in the steel strap and up into a steel 'top hat' threaded socket cast into the external wall, see Figure 4.

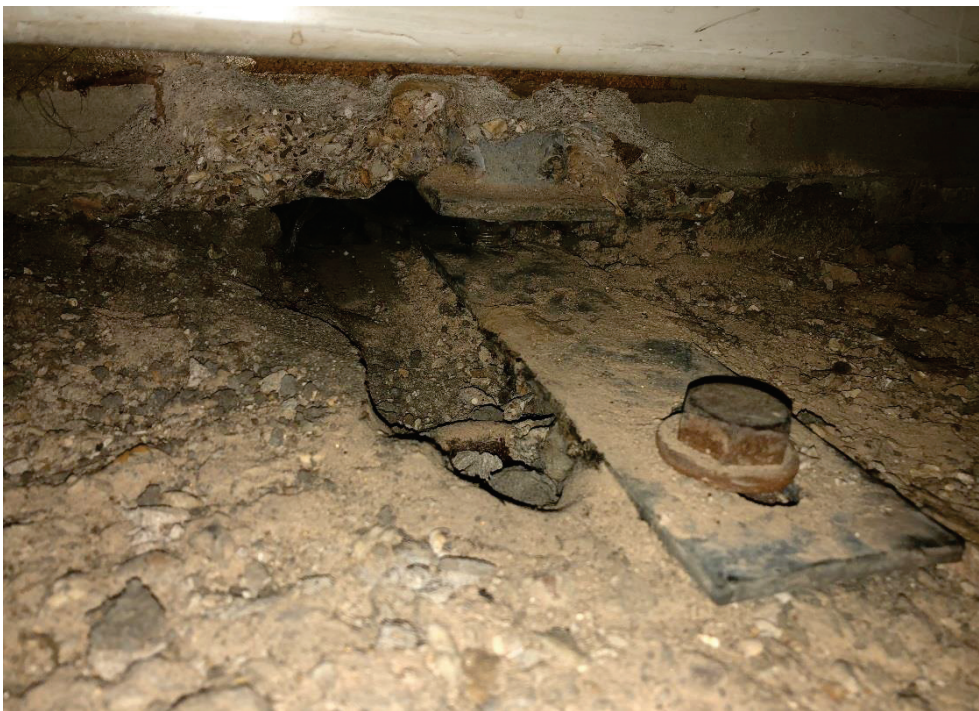
Figure 4 – Kenley: Threaded bar protruding from wall panel below, through hole in the strap, into a steel 'top hat' threaded socket cast into wall panel.

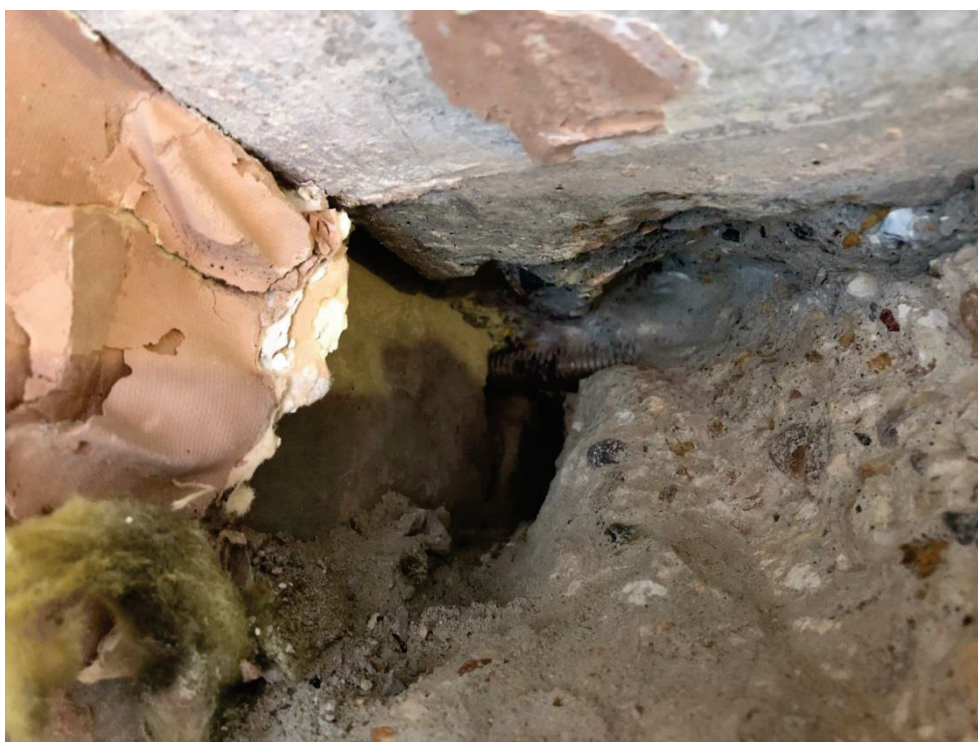
It is believed that an additional fixing tying the non-loadbearing external wall back to the main structure exists within the cross-wall insitu joint, and was part of the original construction of the block. BRE Report 63 shows this detail, see Figure 5, which was confirmed by the opening up works to be present in Flat 42 Kenley, see Figure 6. Being of similar construction it is, therefore, assumed that this detail is also present in all blocks.

Figure 6 – Flat 42 Kenley - Threaded bar found within insitu cross-wall joint tying the non-loadbearing cladding panel back to the main structure

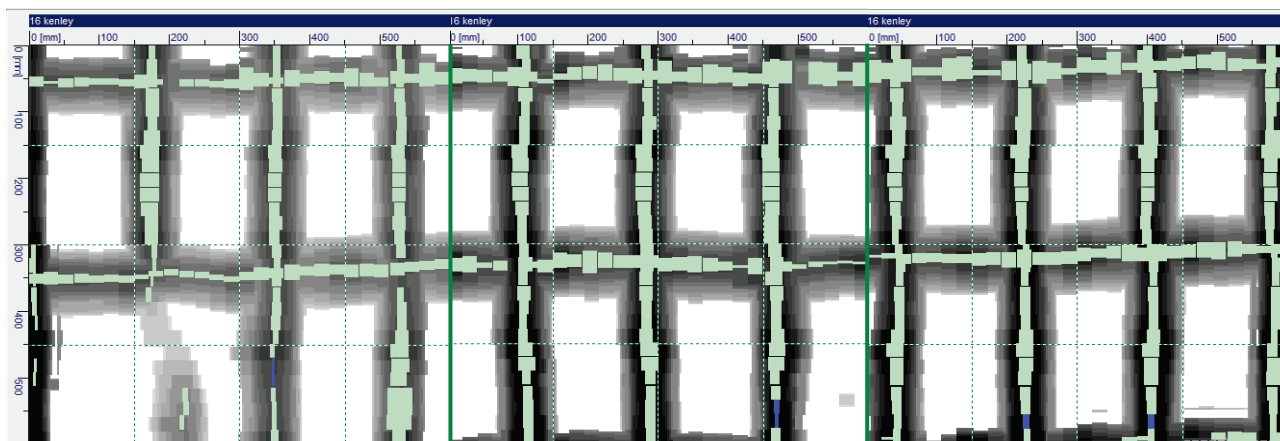
Figure 9 – Example of Three Wall Scans taken in Flat 16, Kenley. The scans clearly show bars at regular 150mm c/c with two clear lateral bars extending the full width of the three scans.

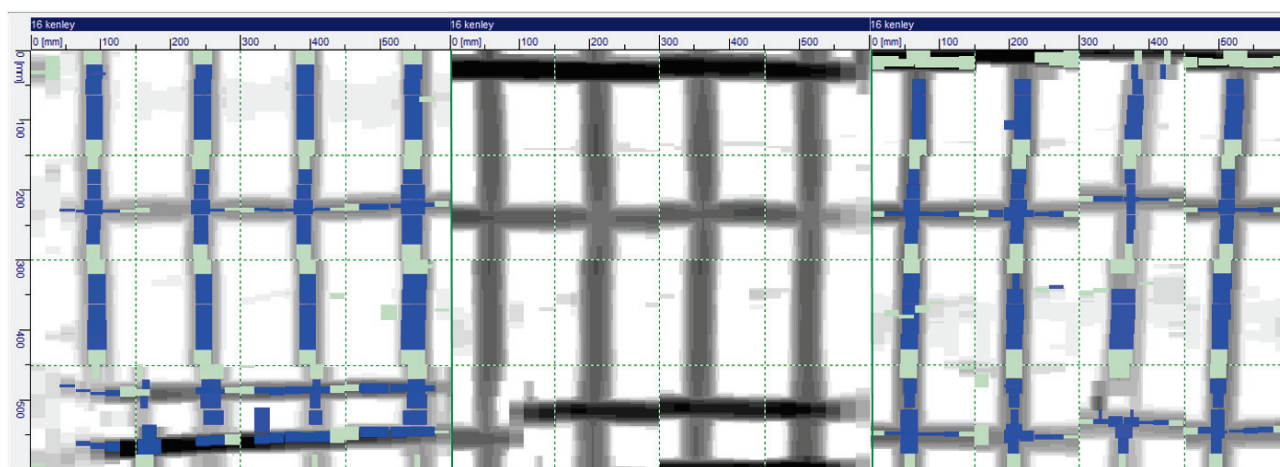
Figure 10 – Example of Ceiling Scan Data taken in Flat 16, Kenley. Scan shows bars at close regular centres at the base of the slab. It should also be noted the difference in clarity between the bars in scan 2 compared to scans 1 & 3. This was a common occurrence throughout the scanning with some bars being harder to identify.

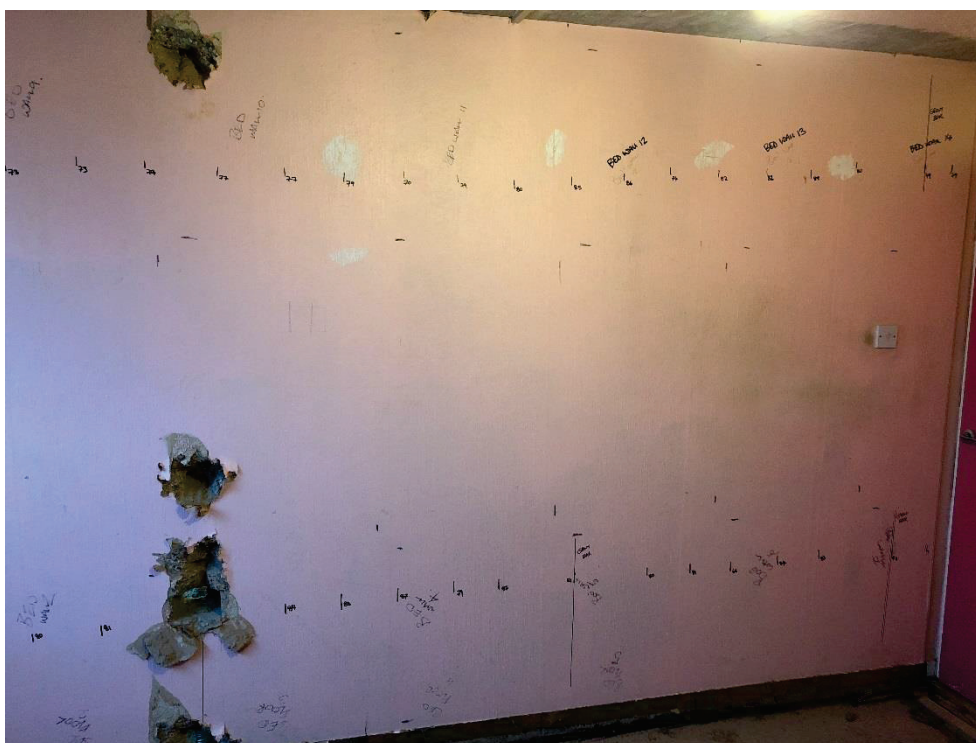
Figure 11 – Wall of Flat 42, Kenley marked-up with the results from the two scans. The information obtained then used to identify areas for further investigation using intrusive methods.

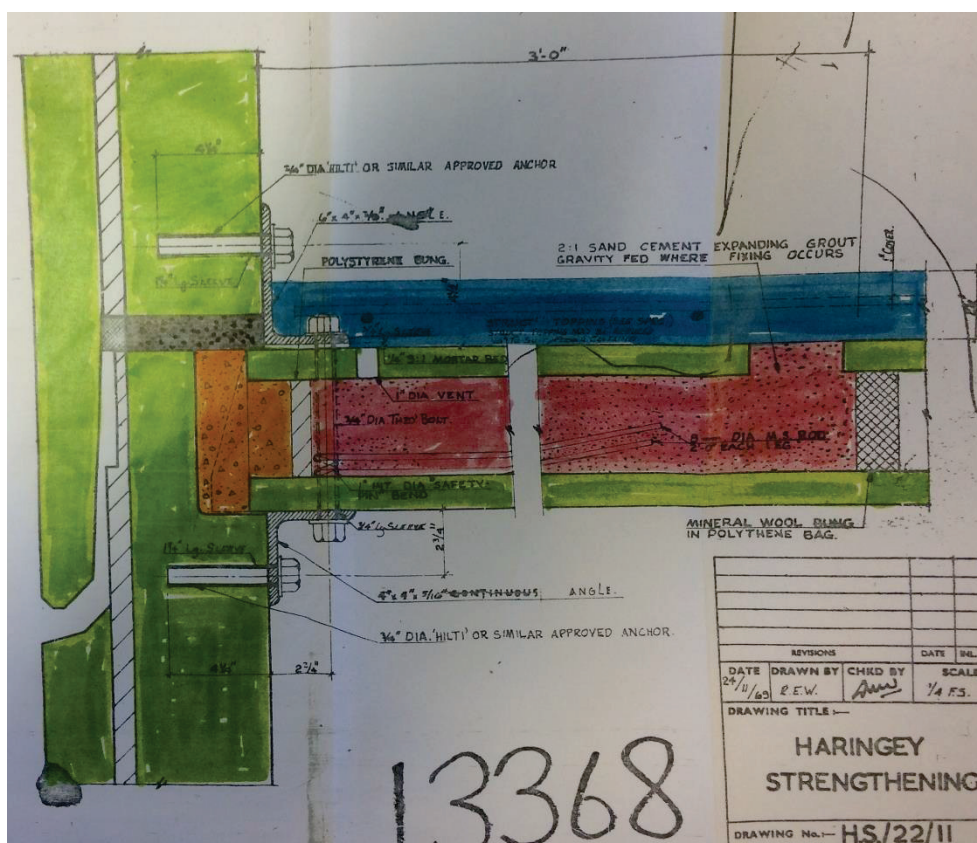
The flank wall connection is formed of two steel angles, one at ceiling level and the other at floor level. The two angles are bolted together, through the floor slab, by M16 bolts at max. 750mm centres. The angles are also bolted to the flank wall panels by M16 bolts at max. 900mm centres inside metal sleeves bonded to the concrete.

Figure 12 – Historic strengthening detail for flank wall joint in Northolt (Phillips Consultants LTD, 1969)

Intrusive investigative works were carried out around the bolts through the floor slab. This area was opened up in both Flat 41 and Flat 55. In both cases the 8mm U-bar, shown in the historic detail to be cast into the grout infilling the core and looping around the bolt had not been installed, as per the design. In both instances the entire core was exposed.

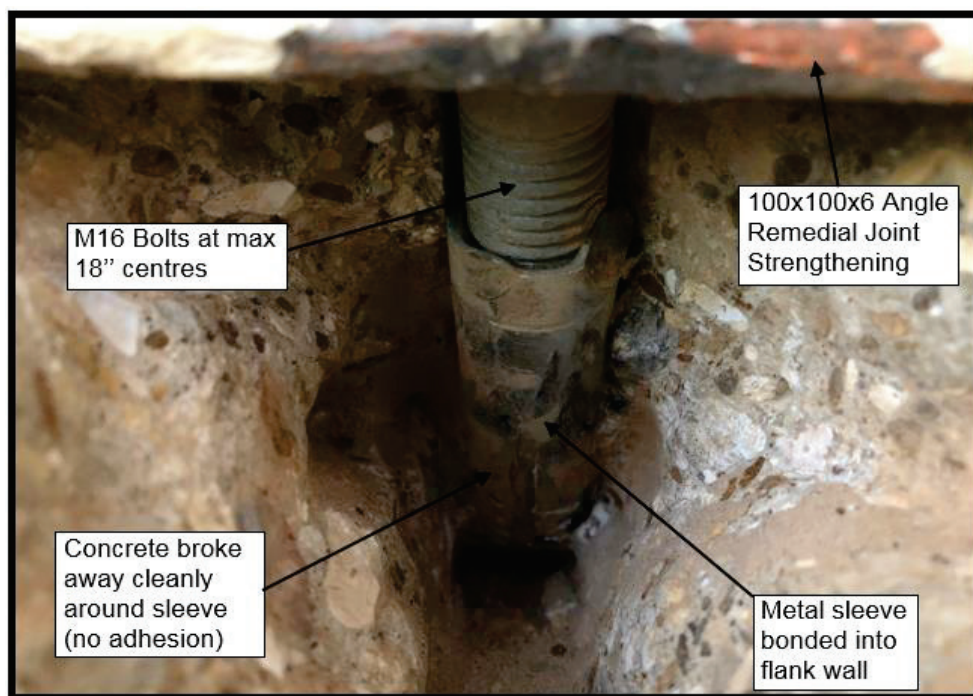
Pockets were also created in the flank wall panel around the sleeved anchors. The intrusive works showed that the total embedment of the anchor was circa 100mm. The metal sleeve was also exposed to be smooth, with little adhesion to the concrete panel which was demonstrated by the concrete breaking away cleanly from the sleeve. Figure 13 shows a pocket around one of these fixings.

Figure 13 – Photo-log of pocket around sleeved anchor into flank wall panel.

The HIS-N anchors were shown to be sufficient to resist failure for the over-pressure of 17kN/m². However, the differences between the HIS-N anchors to the actual fixings used for the strengthening works were deemed significant. The installed fixings are therefore likely to be inadequate to resist the over-pressure loading, thus not satisfying LPS Criterion 1.

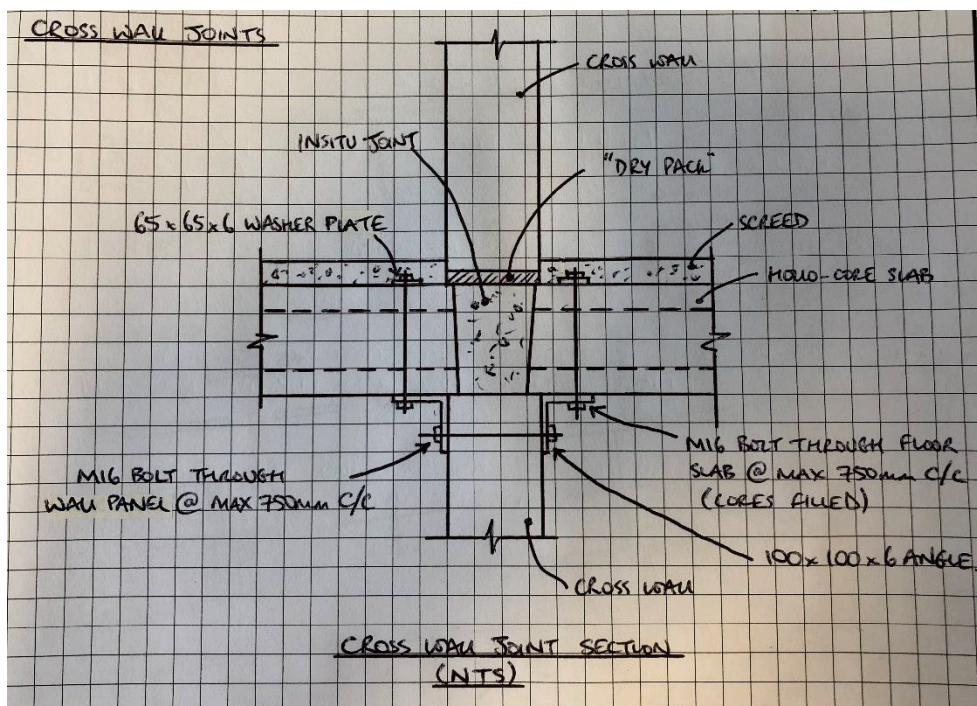
The cross-wall joint is formed of two steel angles, both at ceiling level, bolted together through the cross-wall at max. 750mm centres. The angles are also bolted, through the floor slab, at max 750mm centres to 65mm square washer plates. There was no connection to the base of the cross-wall panel.

Figure 14 – Indicative cross-wall joint detail from investigative works

As there is no connection to the base of the cross-wall panel there the connection does not possess an effective vertical tie. Therefore, the connection does not satisfy LPS Criterion 1.
