Homes for Haringey

**BROADWATER FARM ESTATE
STRUCTURAL ROBUSTNESS ASSESSMENT
TANGMERE (6 STOREY ZIGGURAT) REPORT**
April 2018

This report specifically addresses the findings for the Tangmere block which is of Ziggurat form and which is unlike the other 6 story blocks (that have been reported upon separately).

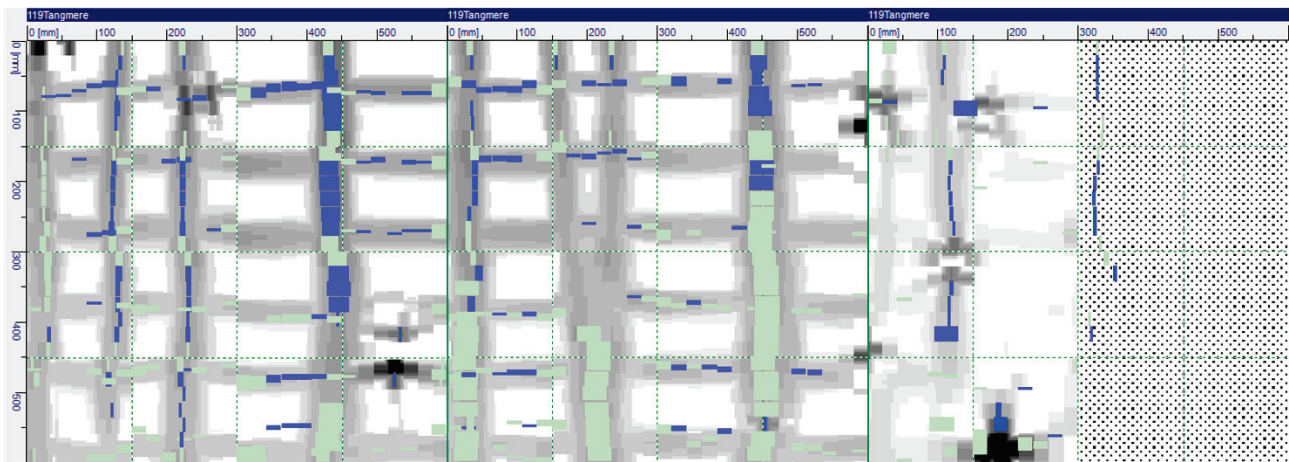
Figure 6 – Example of Three Wall Scans taken in Flat 119 Tangmere. The scans clearly show small diameter bars at close regular centres with two distinctively larger diameter link bars at approximately 600mm centres. Lateral bars at circa 100mm centres are shown to extend the full width of the three scans. It should also be noted the difference in clarity between the bars in scan 1&2 compared to scan 3. This was a common occurrence throughout the scanning with some link bars being harder to identify.

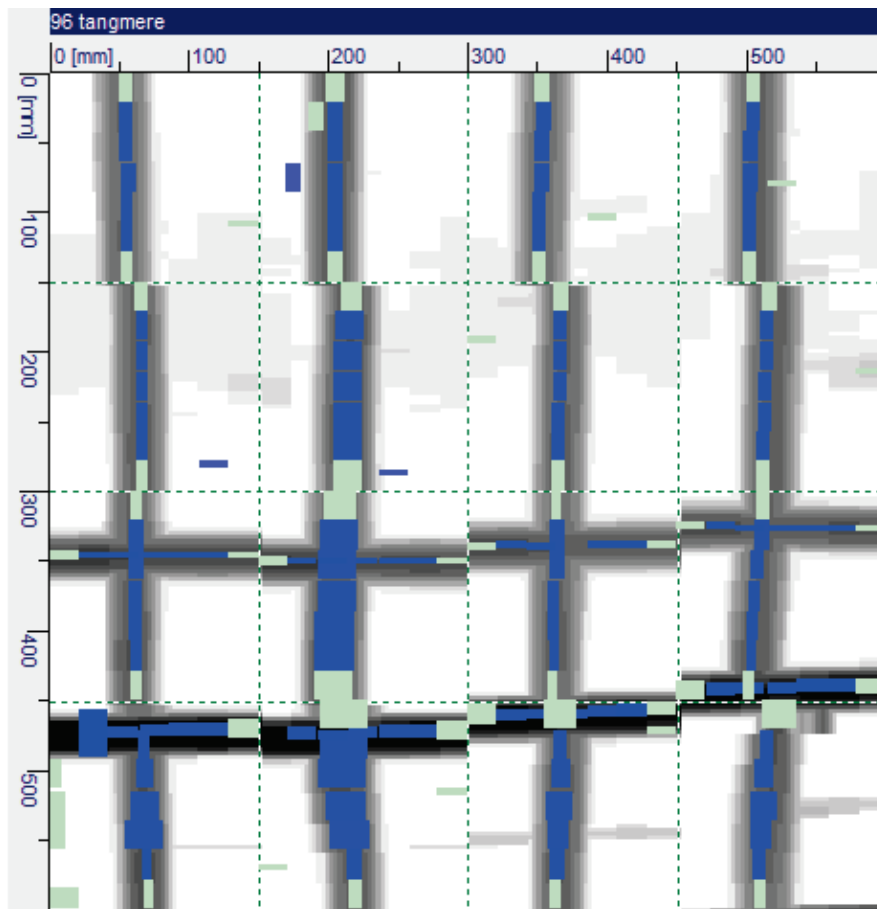
Figure 7 – Example of Ceiling Scan Data taken in Flat 96 Tangmere. Scan shows bars at close regular centres at the base of the slab.

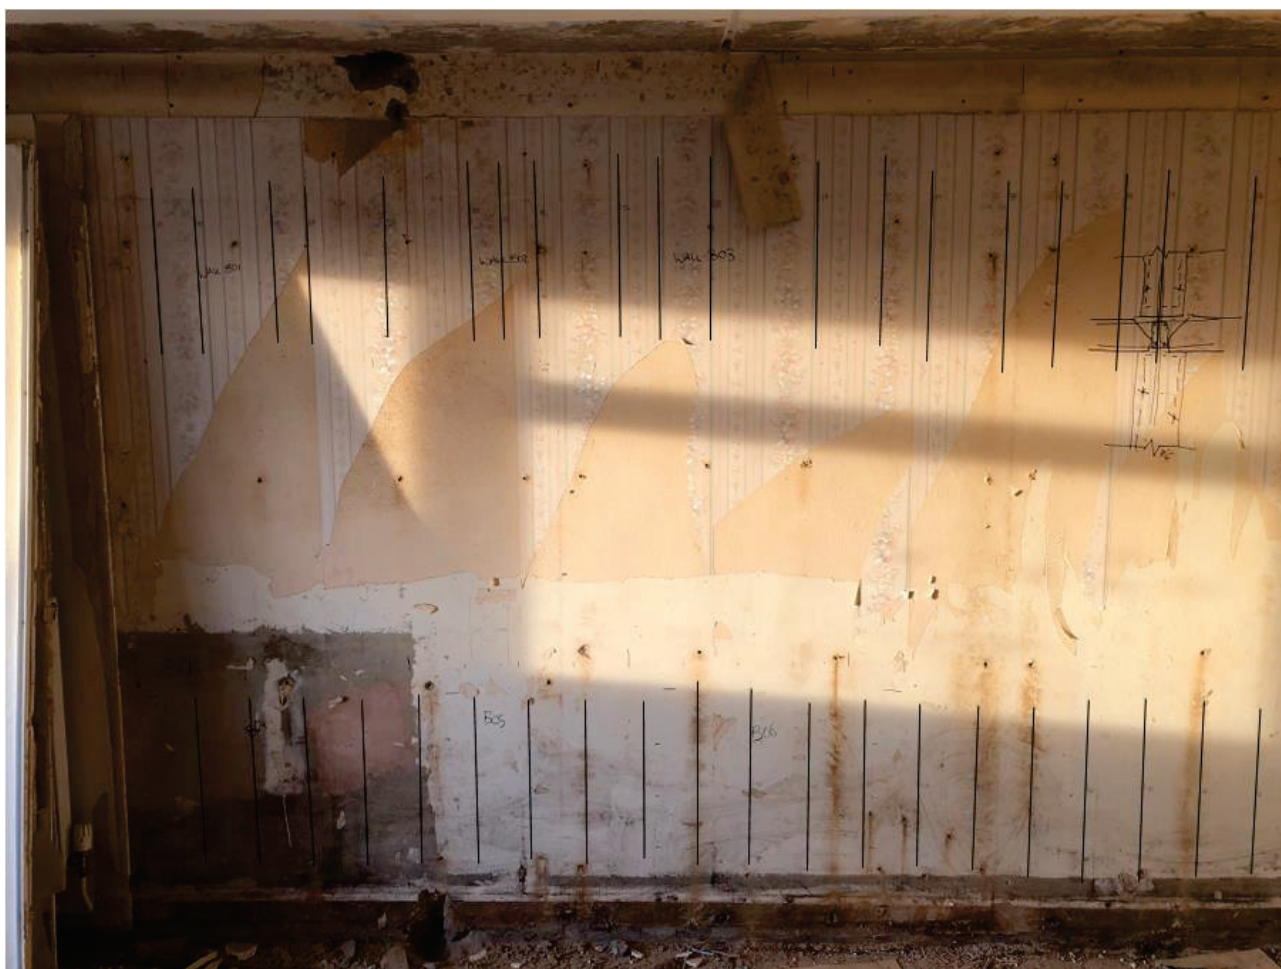
Figure 8 – Wall of Flat 2, Manston marked-up with the results from the two scans. The information obtained then used to identify areas for further investigation using intrusive methods.

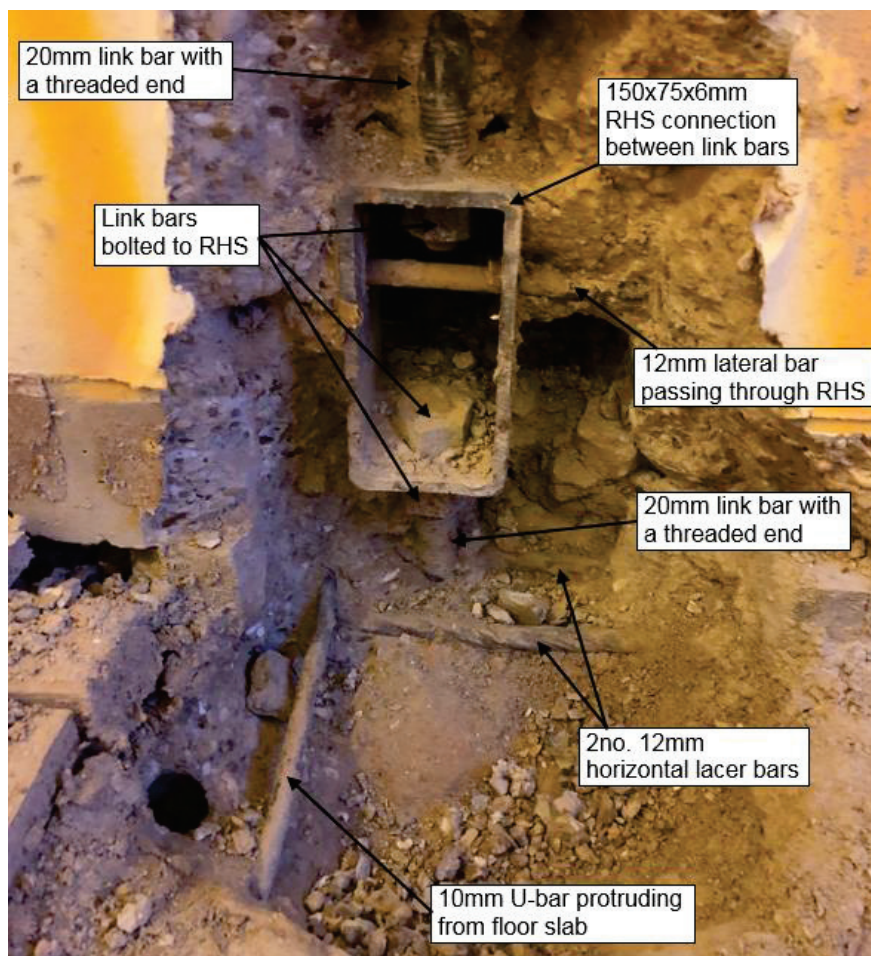
Figure 9 – Link bar connection in cross wall panel

Assessment of the cross wall joints exposed during the intrusive investigation revealed that there were 10mm diameter U-bars at 12" centres protruding from the edges of the precast floor slabs. The U-bars from the adjacent floor slabs were joined within the joint with 2no. 12mm diameter lacer bars. This connection constituted the horizontal tie in the joint. This connection method is highlighted in MHLG Circular 62/68 as an acceptable horizontal tie connection.

The vertical tie in the cross wall joints consisted of 20mm bars at 4' centres cast into the top of each panel, extending up into the insitu joint and the wall panel above. The link bar from the panel below connected to the link bar in the upper panel using a steel box-section inside a formed pocket in the wall panel to which both link bars were bolted to. This connection method is not sufficient to provide an effective vertical tie. In the event of a failure of a cross wall, the floor above which would have originally been taking bearing on the failed wall, would be reliant on hanging from the vertical bars protruding down from the wall above. These plain round bars would offer little tensile resistance due to the minimal bond a smooth bar achieves. A pull-out failure of the bars would therefore be likely, causing the floor to fall away from the wall above. Therefore, the connection does not satisfy LPS Criterion 1.

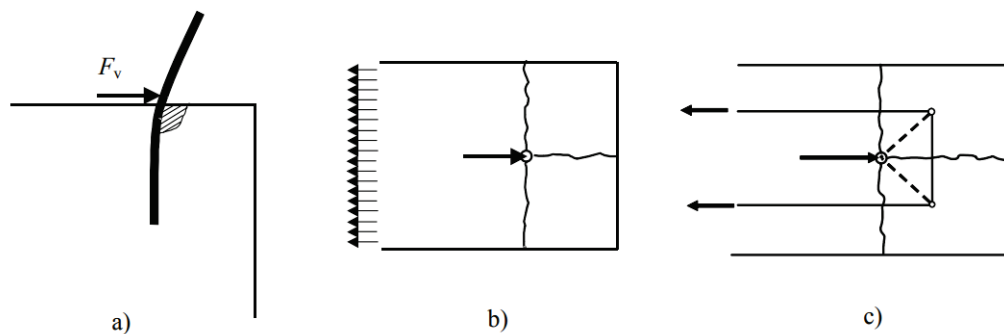
In the cross walls the likely failure mechanism was identified as local shear splitting failure around the 20mm link bars as these bars are the only reinforcement to extend into the joint. Diagrams of this failure can be seen in the extracts from fib Bulletin 43 in Figure 10 and Figure 11.

Figure 11 – Splitting effects around dowel pin loaded in shear, a) shear force acting on dowel bar indicating area of concrete under dowel subject to high stress concentration, b) potential planes of cracking, c) strut and tie model for design of splitting reinforcement – no splitting reinforcement found within wall panels.

The calculation for shear splitting failure of the cross walls around the grout bars was carried out in the assessment for the 6-storey blocks. The wall panels were shown to fail under the 34kN/m^2 overpressure. Therefore, by inspection the cross wall panels in Tangmere will also not be sufficiently robust to withstand the loading.

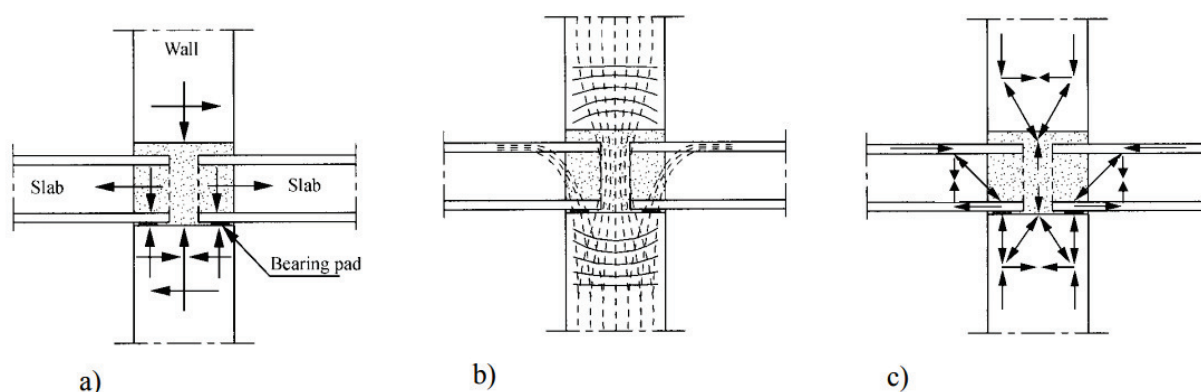
Figure 12 – Slab-wall connections, a) forces, b) simplified stress analysis, c) strut-and-tie model (fib, 2008)

During the investigation into the robustness an observation was noted that the reinforcement found within the joints does not effectively deal with the stresses known to be present in joints of this construction. The forces and stresses present in the joints can be seen in the extract from fib Bulletin 43 in Figure 12.

For example, U-bar reinforcement is normally found to the bottom of the wall panels, the base of the wall panels investigated did not have such reinforcement. However, from our observations on site there were no obvious signs of structural distress from the lack of the appropriate joint reinforcement, this is most likely due to the low stresses contained within the joints of the current structural configuration.
