Section 19 Flood Investigation Report

Hornsey and Crouch End, London Borough of Haringey

M01600-14_DG01 | January 2022

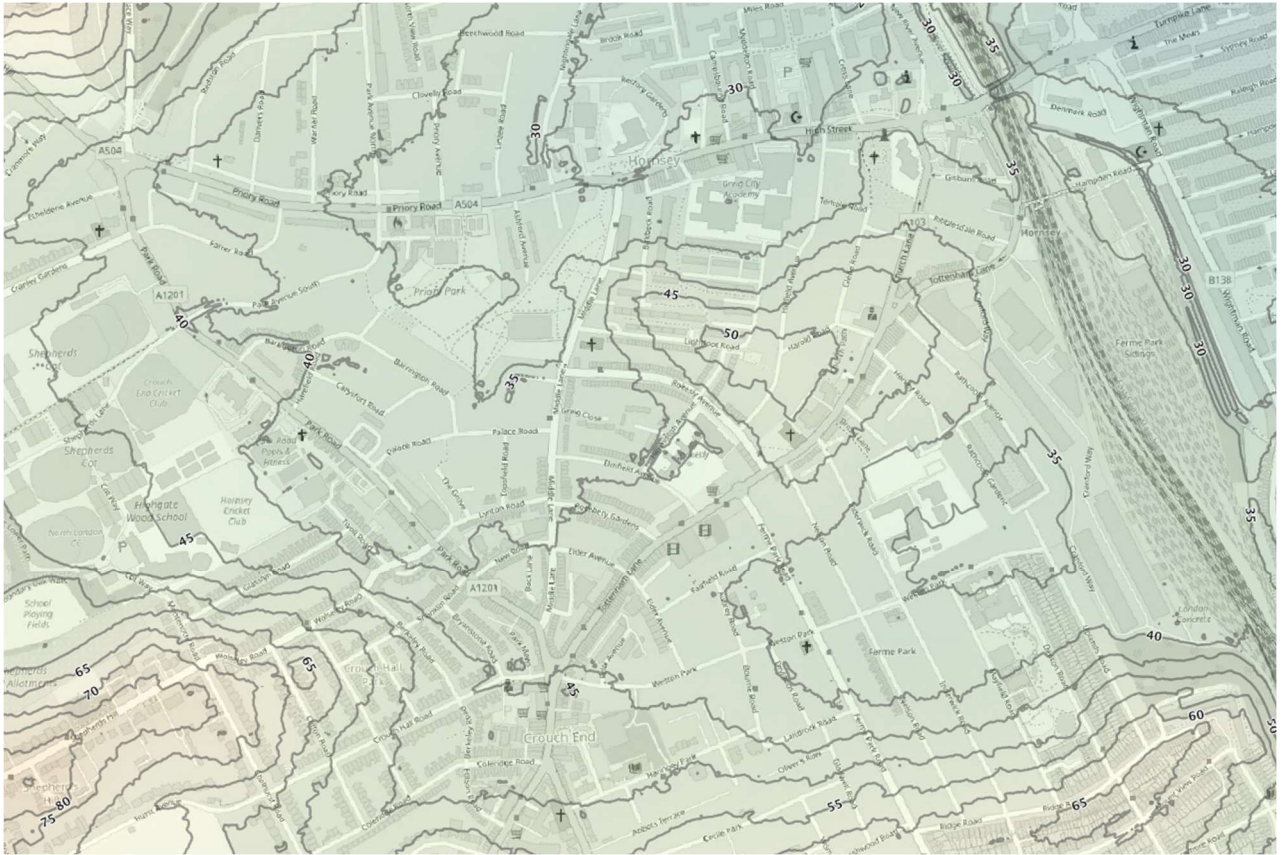
Figure 2-2 Topography of Hornsey and Crouch End within London Borough of Haringey

The topography of the study area is characterised by four primary high points: along Muswell Hill at the bound of Alexandra Palace Gardens to the north west (90m above ordnance datum (AOD)); at Hillfield Avenue in the east (50mAOD); along Shepherds Hill in the south west (80-100mAOD); and along Ridge Road in the south east (65mAOD). Lower land between these high points generally falls to the east.

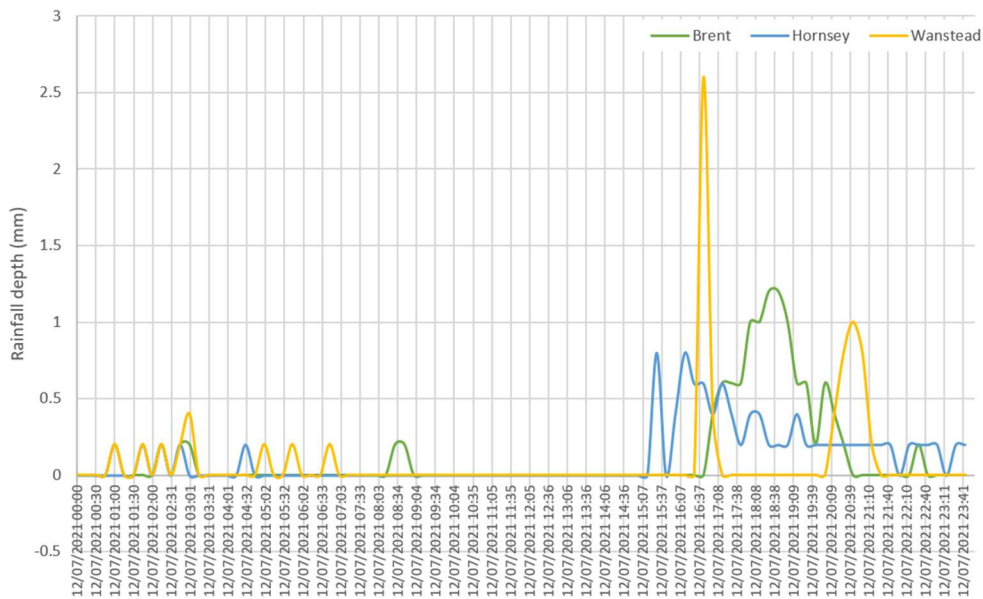
Figure 4-2 Rain gauge data, 12th July 2021

The most significant rain was recorded at Brent Reservoir between 17:00pm and 19:00pm, which recorded 7.6 mm of rainfall within this period. This rainfall is estimated as 1 in <2 year return event based on comparison of data obtained from the Flood Estimation Handbook. A total of 11.6mm was recorded for the whole day, with 10.2 mm of this falling over 3.5 hours. The rain gauge at Wanstead recorded 8mm over 24 hours, and the gauge and check gauge at Hornsey gave unreliable readings on the day due to apparatus blockages.

The relatively low rainfall recorded above is not consistent with the flood reports and anecdotal evidence provided from the area. The Hornsey gauges were blocked on retrieval of data and the recordings conflict with the Thames Water analysis of the event, which was presented at a recent workshop related to the floods⁴, and indicated that the district received rainfall return periods ranging from a <30 year to a <50 year event. The areas in which the gauges are located in Brent (Borough) and Wanstead (London Borough of Redbridge) did not experience the same intensity of rainfall experienced elsewhere, which concurs with the relatively low estimated rainfall return period derived from the rain gauge data for these locations.

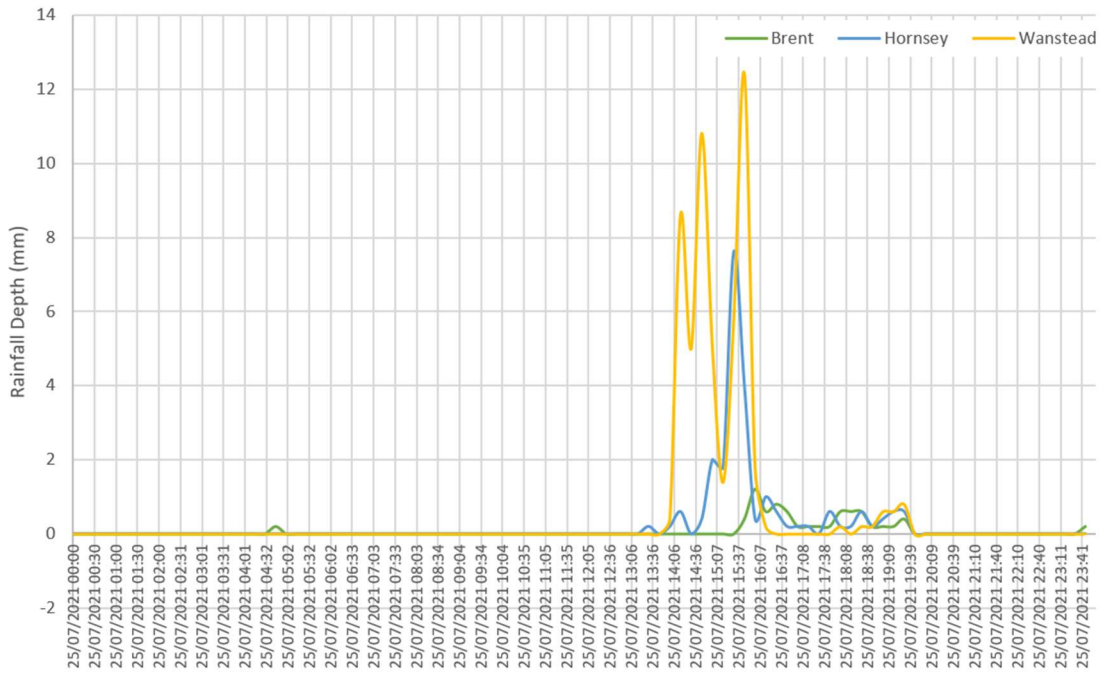
Figure 4-4 Rain gauge data, 25th July 2021

The most significant rain being recorded at the selected gauges was between 14:15 and 15:45 at Wanstead. The rain gauge recorded 49 mm of rain within this time period, which was estimated to be a 1 in 70 year rainfall return event. A total of 54 mm was recorded for the whole day. The rain gauges at Brent Reservoir and Wanstead recorded 7.6mm and 22.8mm, respectively on this date.

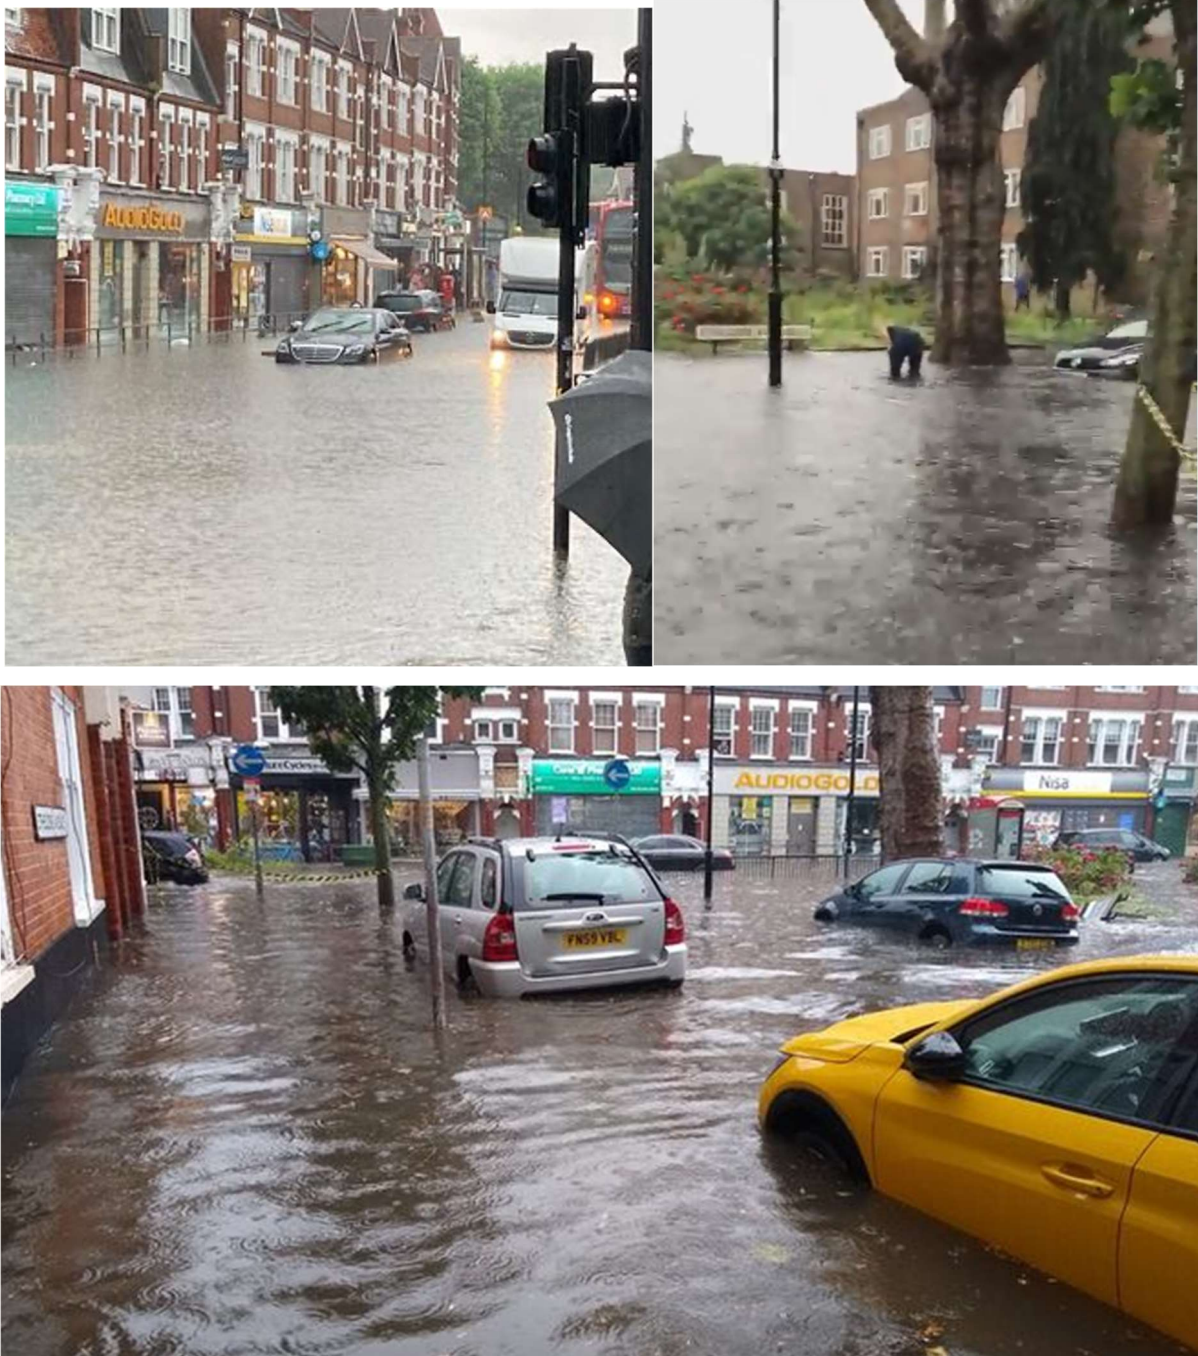
Figure 5-4 Flooding on Park Road and Etheldene Avenue, 12th July 2021

Reports of flooding were received from businesses in the northern extent of Park Road, where major flooding of the highway was reported as well as damage to footway paving at Etheldene Avenue and Cranley Gardens. Photographs and videos circulated on social media indicate the spread and depth of flooding along Park Road outside units 308-310 Park Road and the junction with Etheldene Avenue, as well as locals trying to unblock drains in the carriageways. This is shown below.

The photographic evidence, local topography and available flood reports suggests that the primary cause of the flooding was excessive rainfall which exceeded the capacity drainage network in this area in combination with the lack of operational gully pots. Further investigation would be required to identify whether the capacity issues were primarily due to the receiving capacity of the highway drains / gully pots, the public sewer, or a combination.

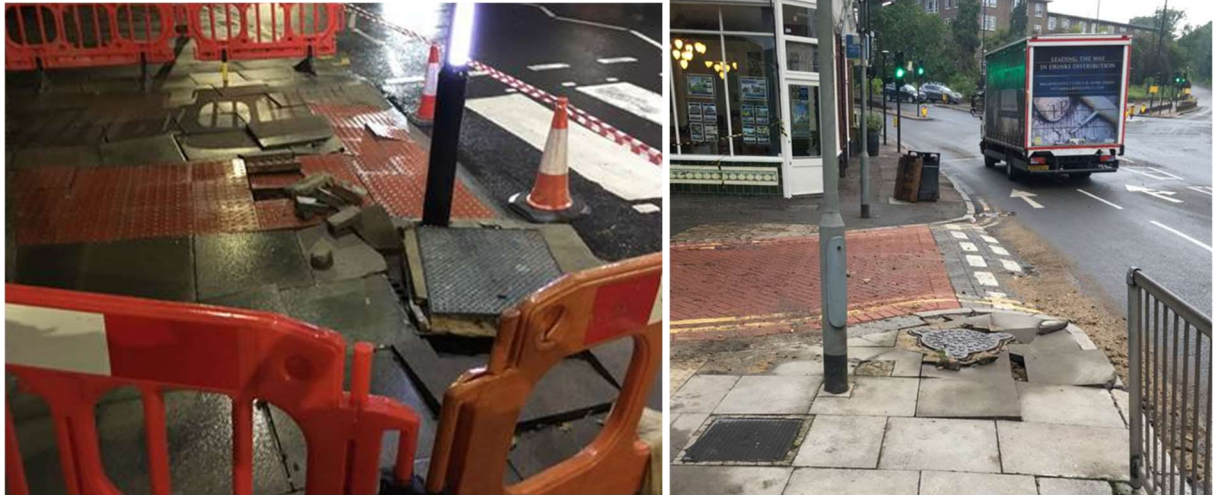
Figure 5-5 Pavement damage, Cranley Gardens and Etheldene Avenue

As the flood waters receded it became apparent that paving slabs and manhole covers had been lifted as shown below. Haringey Council instructed Marlborough Highways to attend the area to make safe the damaged footways and manholes.

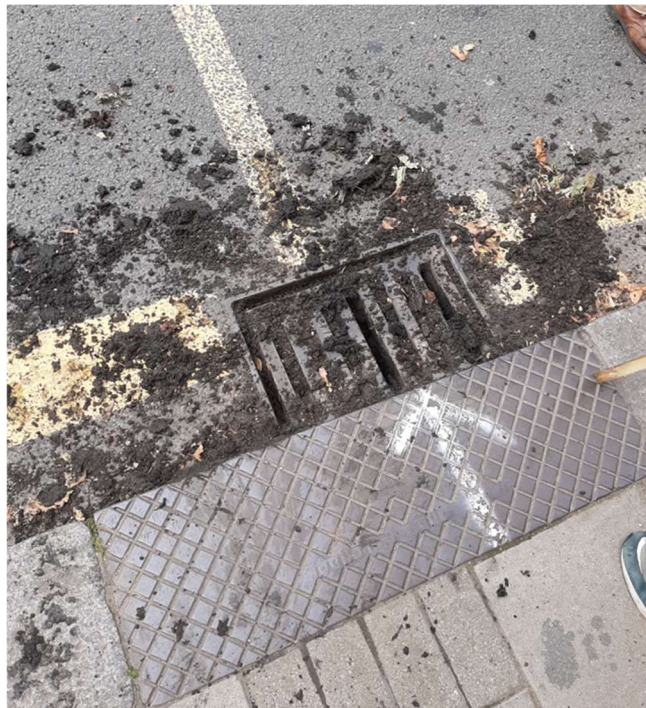
Figure 5-6 Failed attempt to unblock gully outside 308-310 Park Road

One of the business owners at 308-310 Park Lane has repeatedly asked for drains on Park Road to be cleared. During a visit by Councillor Cawley-Harrison following the 12th July floods, it was noted that the gullies outside the premises had still not been cleared despite the severity of the flooding observed. It was noted by the business owner and Councillor Cawley-Harrison that off the 6 gullies serving this low point, 5 were blocked during the 12th July event, and only 1 had been cleared prior to the 25th July event. Such blockages would have further reduced the capacity for surface water to enter reach the public sewer.

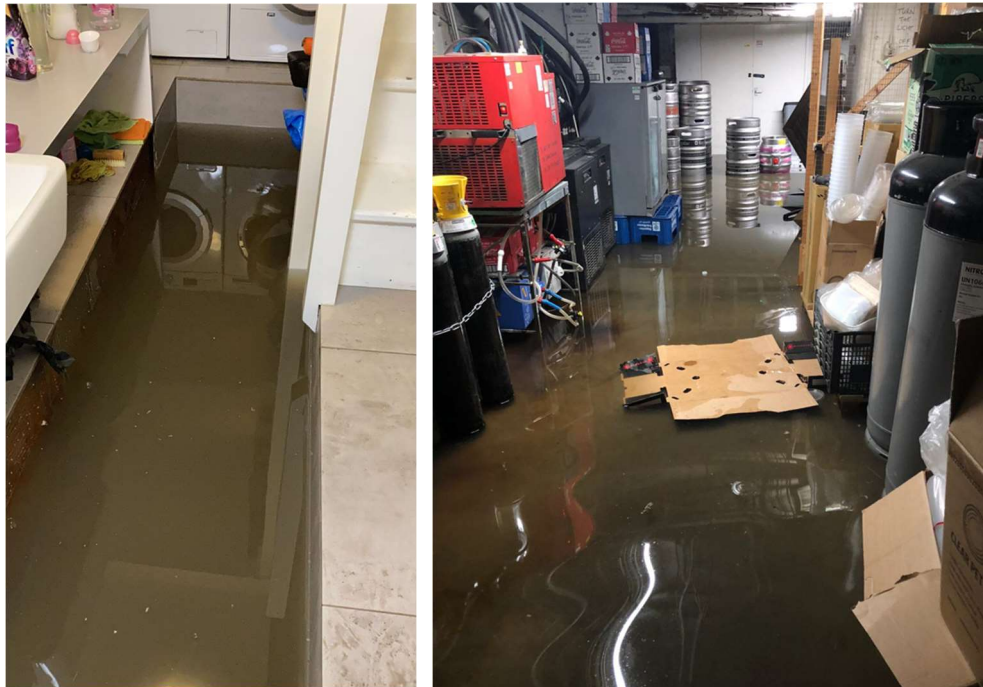
Figure 5-8 Flooding of property on Tivoli Road and Basement flooding in business, 70 Park Road, 12th July 2021

Based on conversations held during Councillor Cawley-Harrison's visits, property owners (residents located along Palace Road and businesses between the Princess Alexandra and Maynard Arms pubs), experienced basement flooding which appeared to originate from underground sources rather than flows entering the basement from the surrounding surface catchment. The basement flooding in the Maynard Arms rose to circa 300mm depth.

Residents of Gransden House (115-119 Park Road), View Crescent and Tivoli Road described how surface water appeared to flood their properties from the road. The minutes of the GMTRA meeting indicate that most flooding of properties on View Crescent was limited to flooding of under floor spaces as a result of surface water entering the property via air bricks. Three garages and two conservatories were flooded on View Crescent, with one resident reporting up to 300mm depth of water. At least 36 properties on Tivoli Road and Glasslyn Road reported experienced flooding, 25 of which experienced basement or cellar flooding. Properties between 1 and 10 Glasslyn Road described the floodwaters as coming through the walls of their basements and cellars. Three residents also described how flooding within their property had occurred as a result of their drains backing up into their property. Other properties indicated that flooding had occurred in their properties as a result of build-up or runoff of surface water from their gardens, the roads and uphill properties.

The photographic evidence, local topography and available flood reports suggests that the primary cause of the flooding was excessive rainfall which exceeded the capacity drainage network in this area. The intensity of the rainfall meant that surface water was unable to enter the sewer network fast enough and accumulated in the topographical low points, causing flooding of the highway. Given the intensity of rainfall for the two rainfall events, it is likely that the rate of runoff may have exceeded the receiving capacity of gully pots on steeper streets such as Glasslyn and Wollesley Roads, resulting in more runoff reaching lower areas at Tivoli Road, View Crescent and Park Road.

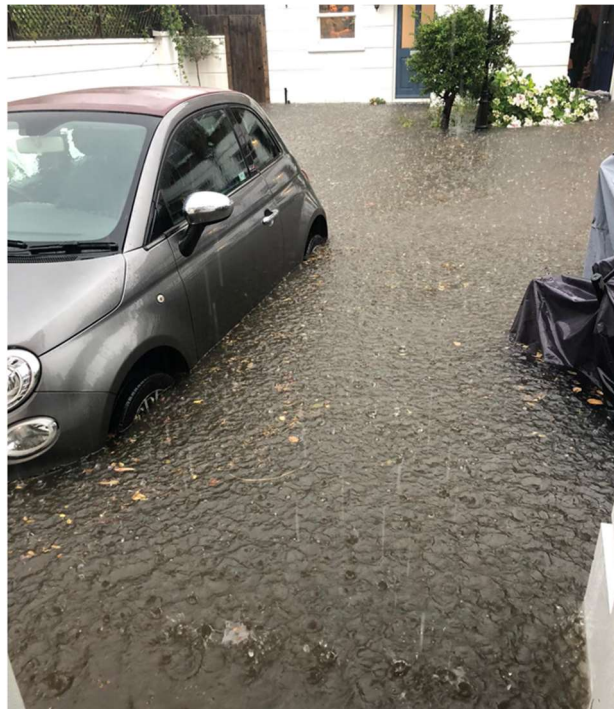
Figure 5-9 Flooding of property in Glasslyn, Montenotte and Tivoli Road area

Haringey have noted from a meeting with GMTRA, that “Many of the surface water problems were caused by rainwater flowing down Shepherds Hill into Montenotte Road and from Wolseley Rd into Tivoli Road”.

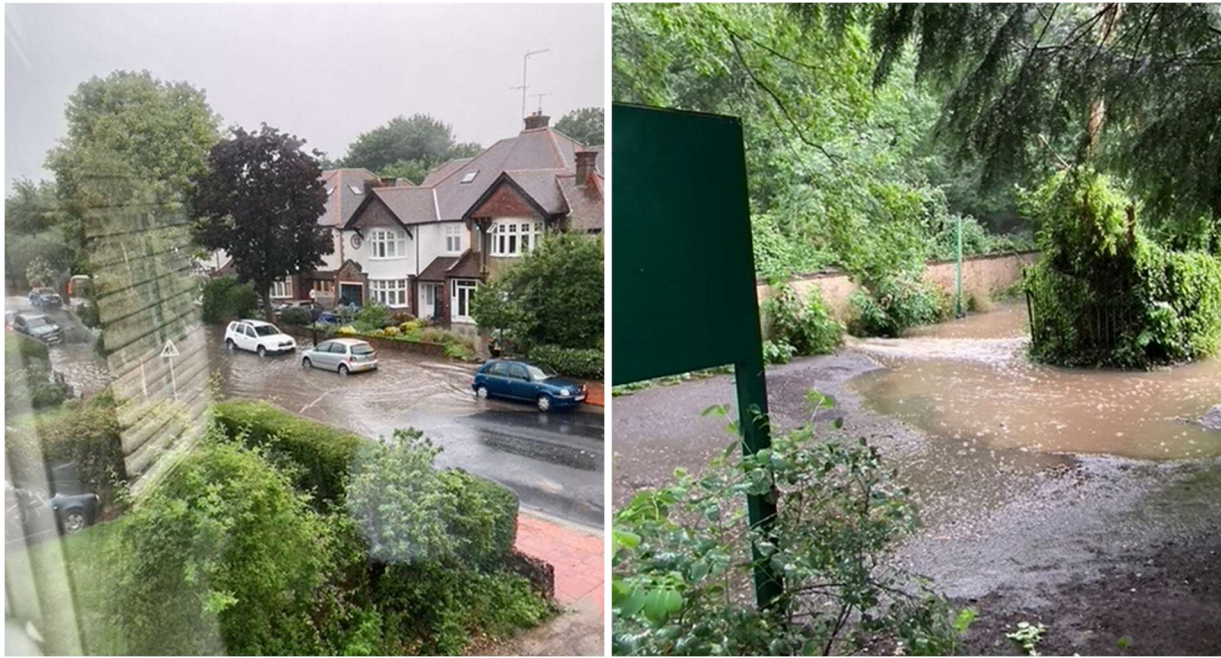
Figure 5-11 Flooding of highway and property along Wood Vale, 12th July 2021

Flooding at Wood Vale was reported to Haringey Council via email correspondence from a resident on 13th July and was not recorded in the flood report schedule or mapping in Figure 5-10. The resident described how the main drain at the foot of the Queen's Wood could not take the water, resulting in at least 10 houses experiencing flooding (it was not confirmed whether this was internal or external flooding). The resident reported that the flood wall in the Queen's Wood was breached causing surface water to flow into residents' gardens. The resident reported that the gully pots further uphill on Wood Vale were blocked. Associated photographs of Wood Vale on 12th July are presented in Figure 5-11 below.

The photographic evidence, local topography and available flood reports suggests that the primary cause of the flooding was excessive rainfall which exceeded the capacity of the drainage network in this area. The intensity of the rainfall meant that surface water overwhelmed the existing drainage routes in Queen’s Wood and was unable to enter the sewer network fast enough, resulting in overland flows accumulating in the topographical low point in Wood Vale and causing flooding of the highway. Given the intensity of rainfall, it is likely that the rate of runoff may have exceeded the receiving capacity of gully pots on the steeper sections of the road, resulting in more runoff reaching the low central section of Wood Vale. Surcharging or flooding of the Moselle Brook may have increased flooding on the carriageways and footways. Further investigation would be required to identify whether the capacity issues were primarily due to the receiving capacity of the highway drains, the public sewer, the culverts, or a combination. The DWMP indicates that surcharging part of Wood Vale occurs during a 1 in 2 year rainfall event. In any case the following item was identified that may have affected the depth and magnitude of the flooding, including:

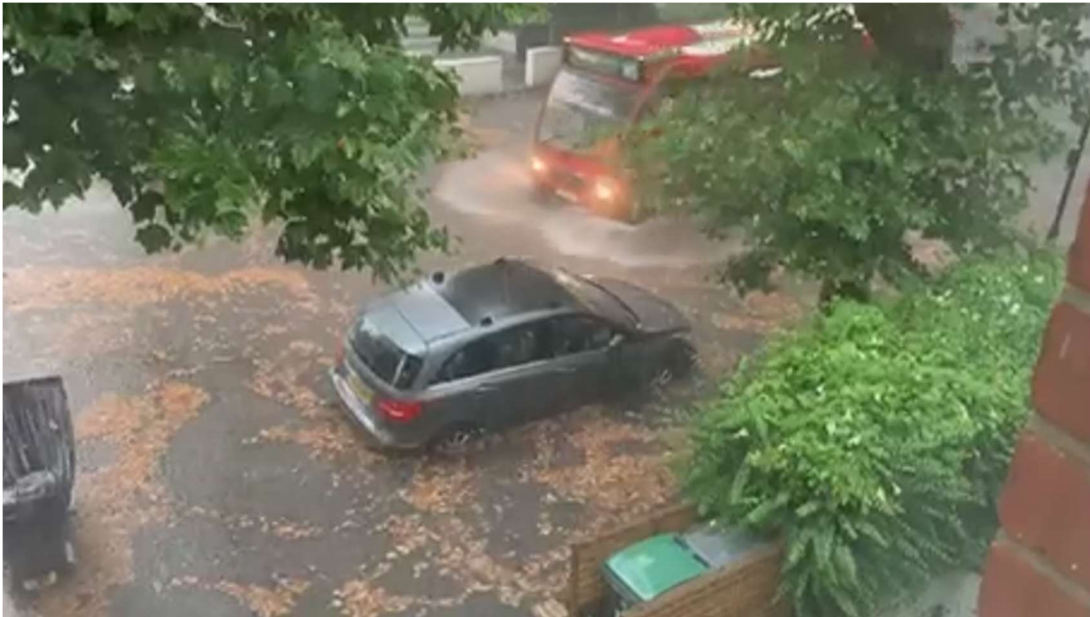
Figure 5-13 Flooding on Stapleton Hall Road, 25th July 2021

LFB received flooding related calls from Stapleton Hall Road at 16:24pm. Haringey Council also recorded a call from Stapleton Hall Road, where an unspecified number of properties had experienced flooding during the rainfall event. Subsequent video footage shows the carriageway and footways submerged in circa 300mm of water, as shown in Figure 5-13. No further information has been obtained for this location.

There is limited reported information on flooding at this location, but the photographic evidence, local topography and information from the DWMP suggests that the primary cause of the flooding was excessive rainfall which exceeded the capacity drainage network in this area. The intensity of the rainfall meant that surface water was unable to enter the sewer network fast enough and accumulated in the topographically lowest part of the residential area along Stapleton Hall Road, causing flooding of the highway and flooding of properties. Further investigation would be required to identify whether the capacity issues were primarily due to the receiving capacity of the highway drains, the public sewer, or a combination.

Video footage from the 25th July flooding along indicates that larger vehicles moving through the flood water caused a bow wave effect. Anecdotal reports from other parts of Haringey indicated bus movement had caused further movement of water onto the footway and into their properties.

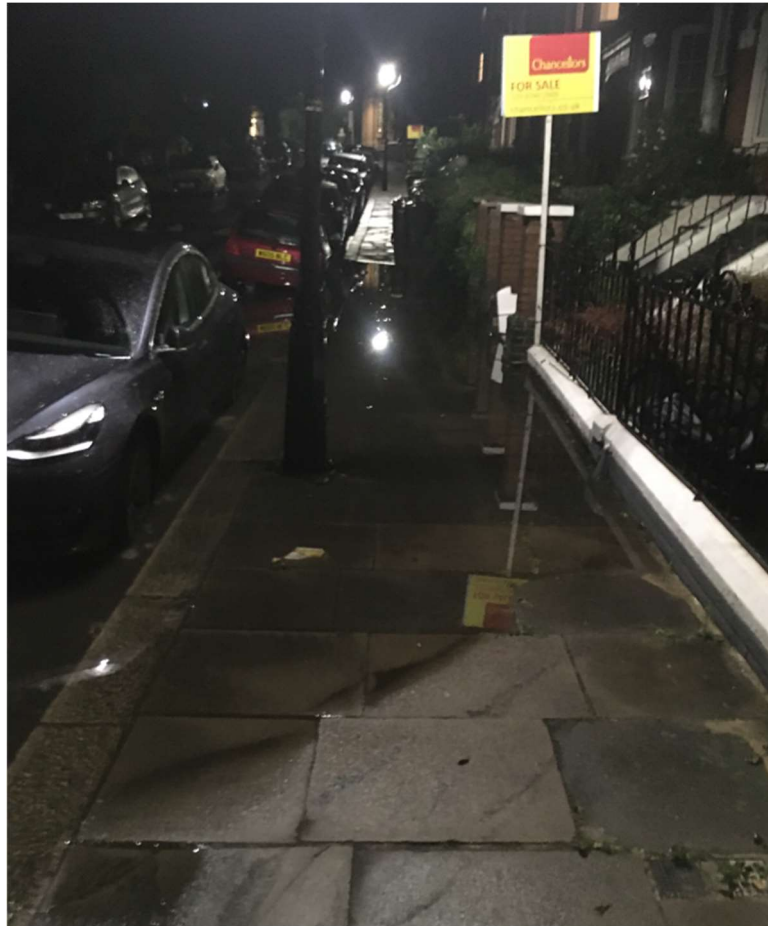
Figure 5-16 Flooding at Hillside Gardens, 12th July 2021

A report of flooding was received from Hillside Gardens, where flooding of the highway was reported. Reactionary crews have noted that some flood water may have encroached into properties. At the time of a visit that evening by Haringey Council, some flood water remained on the carriageway and partially covered one of the footways, as shown in Figure 5-16. Marlborough Highways were called to supply sandbags to residents.

The photographic evidence suggests that the primary cause of the flooding was excessive rainfall which exceeded the capacity drainage network in this area. Exceedance flows from properties higher up the hill may have reached Hillside Gardens where it ponded in localised low spots. Further investigation would be
