FWMA Section 19 Screening Assessment London Borough of Haringey

M01600 20 DG01 | March 2023

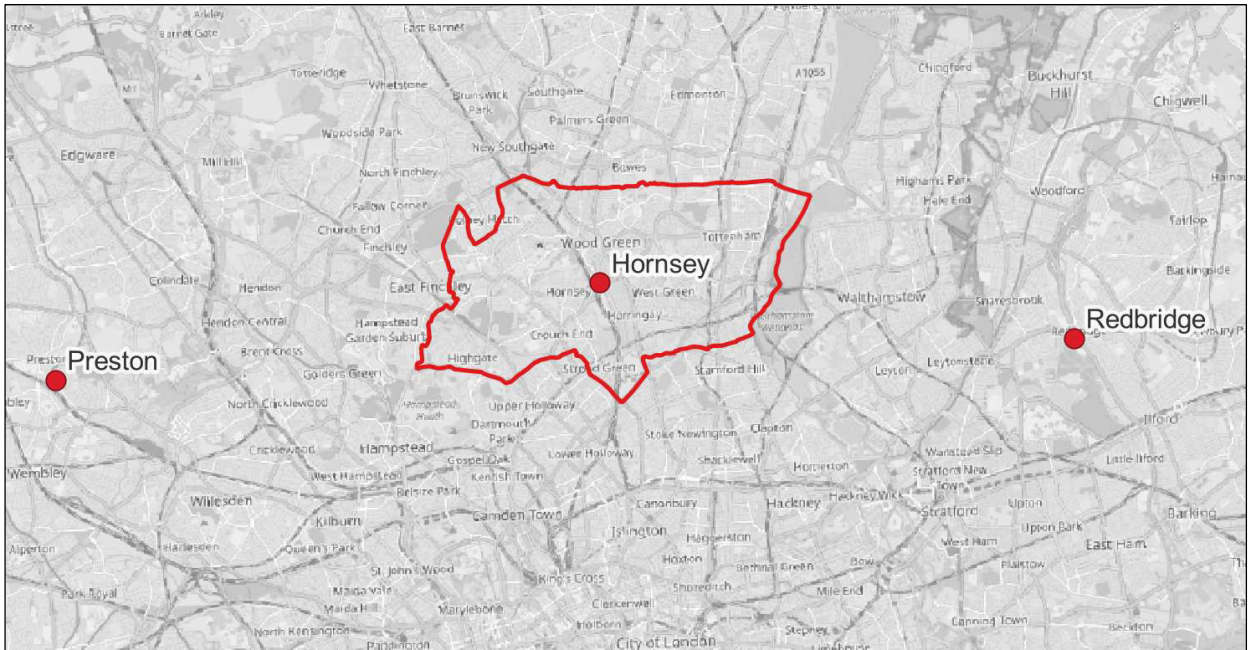
Figure 3-1 Locations of EA Rainfall Gauges

Rainfall data was obtained from the EA for review from gauges located in Hornsey (grid reference TQ 31027 89597), Preston (grid reference TQ 18610 87066) and Redbridge (grid reference TQ 41448 88765).

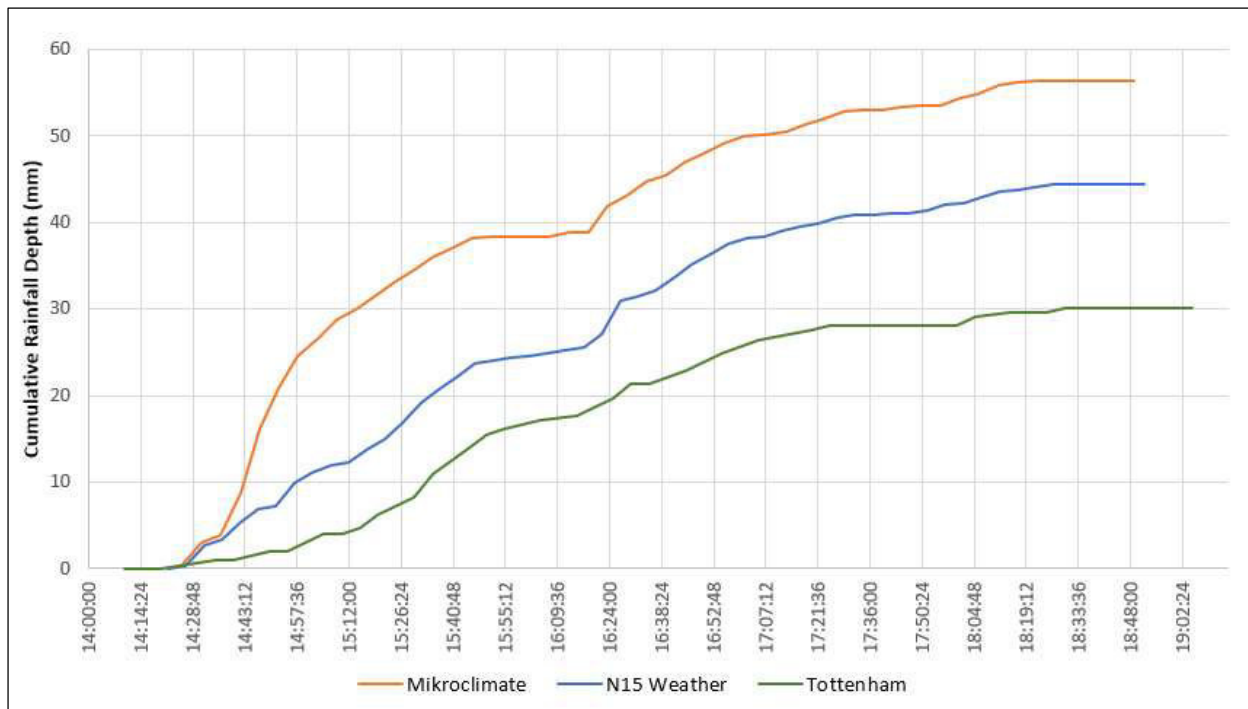
Figure 3-4 Personal rain gauge data, 17th August 2022

The most significant rainfall was recorded by the Mikroclimate station in the south of the borough, which recorded 56.3mm falling between 14:15pm and 18:30pm. This rainfall is estimated as a 1 in 36-year return rainfall event.

The N15Weather station recorded 44.4mm falling between 14:15pm and 18:30pm, which is estimated as a 1 in 14-year rainfall event. The Tottenham station recorded 30.1mm falling between 14:30pm and 16:30pm, which is estimated as a 1 in 4-year rainfall event.

The N15Weather and Tottenham stations are both within 2km of the EA rain gauge located in Hornsey, but both stations recorded higher depths of rainfall. The Mikroclimate station is located c.2km south of the EA rain gauge in Hornsey and is noted to have recorded 28.9mm more rainfall depth than the EA gauge. This data indicates that the varying volume of rainfall across the borough on 17th August 2022 may have been higher on average than what the EA gauge in Hornsey recorded.

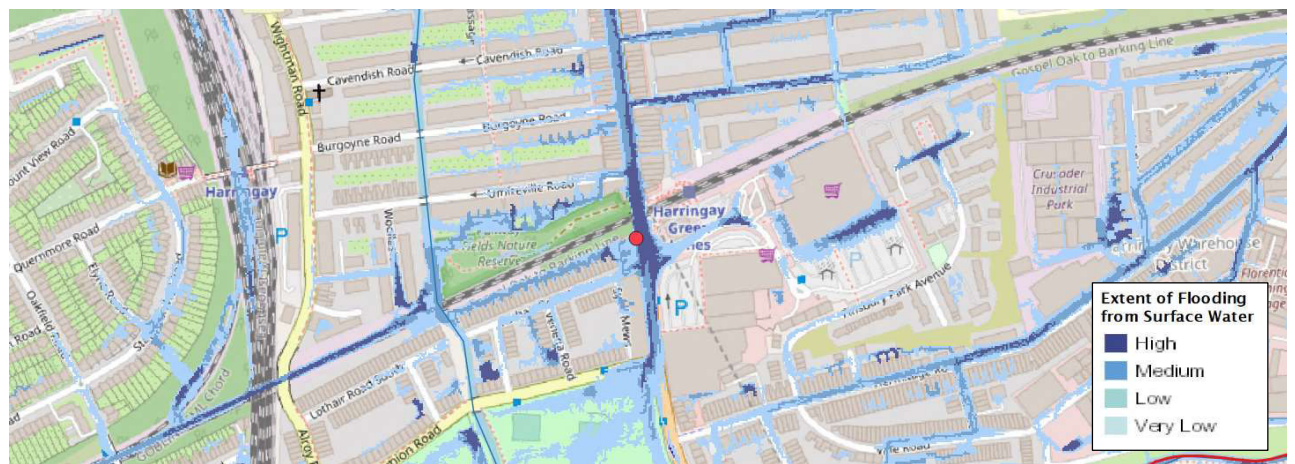
369 Green Lanes – EA Risk of Flooding from Surface Water:

Location	Recorded Impact	Action Taken	Possible Cause
369 Green Lanes (Rakkas restaurant and Manor House Dental Surgery)	Flooding from highway through front door.	Requested highways check nearby gullies/drains. TCM officer to also visit owner.	Unknown
