Homes for Haringey

**BROADWATER FARM ESTATE
STRUCTURAL ROBUSTNESS ASSESSMENT
TANGMERE (6 STOREY ZIGGURAT) REPORT**
April 2018

This report specifically addresses the findings for the Tangmere block which is of Ziggurat form and which is unlike the other 6 story blocks (that have been reported upon separately).

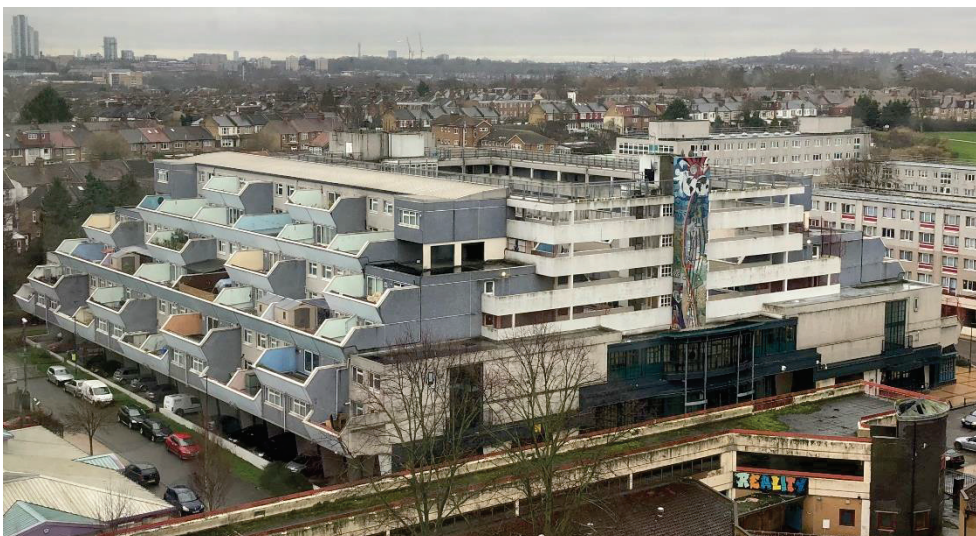
Figure 3 – Tangmere (External view)

Tangmere is a 6-storey dwelling block on the Broadwater Farm Estate. Tangmere is of a different design to the other blocks on the estate, and as such has been considered separately. The block is 'U-shaped' in plan and was built in a ziggurat form, with each successive floor recessed back from the floor below. The main entrance to the building is via the concierge, within which is a lift shaft which services each floor and a stairwell that encompasses the lift shaft. The stair core is internal up to deck level with the upper levels open. Main corridors running along the inner edge of the U-shaped block serve the flats on each level. The flats within Tangmere are a mix of single storey, duplex, and some flats were converted into three-storey

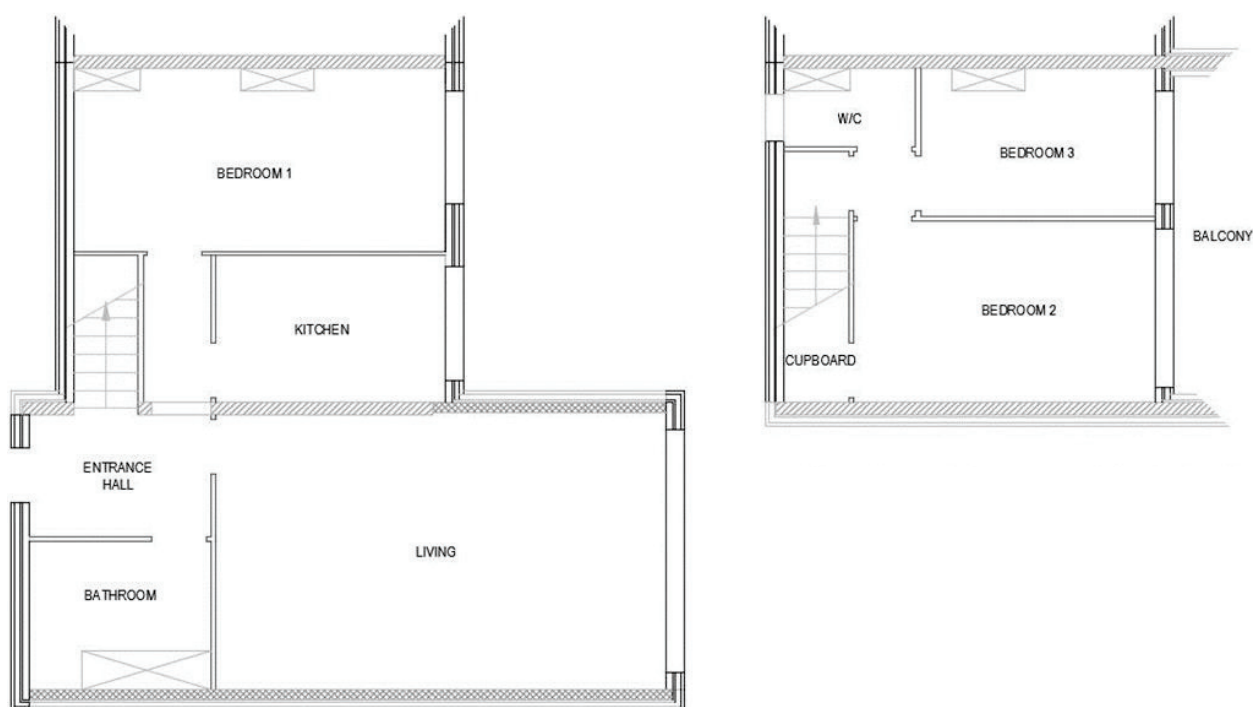
Figure 5 – Example floor plans in 6-storey ziggurat block (Flat 119 Tangmere)

The floor layout for Flat 119 Tangmere can be seen in Figure 5 as an example. The floor plans for all the flats subjected to the investigations have been appended to this document for reference.

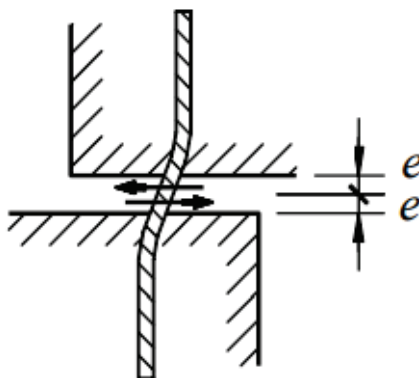
In the cross walls the likely failure mechanism was identified as local shear splitting failure around the 20mm link bars as these bars are the only reinforcement to extend into the joint. Diagrams of this failure can be seen in the extracts from fib Bulletin 43 in Figure 10 and Figure 11.

Figure 10 – Shear transfer by dowel action with double fixation (fib, 2008)
